Interim Report

September 2015

1. BF15/14: Conservation of the Western Surrounding Walls (West Gate to Western Defences), Butrint

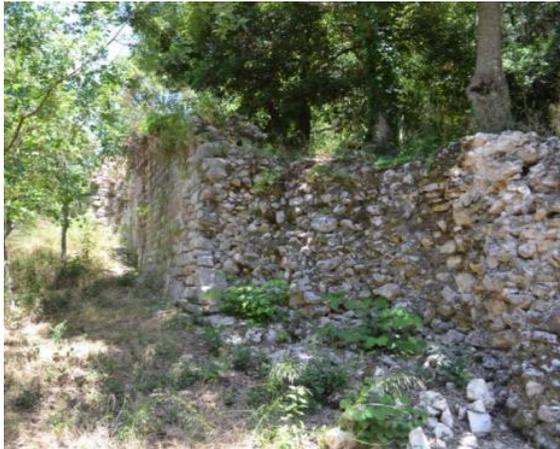
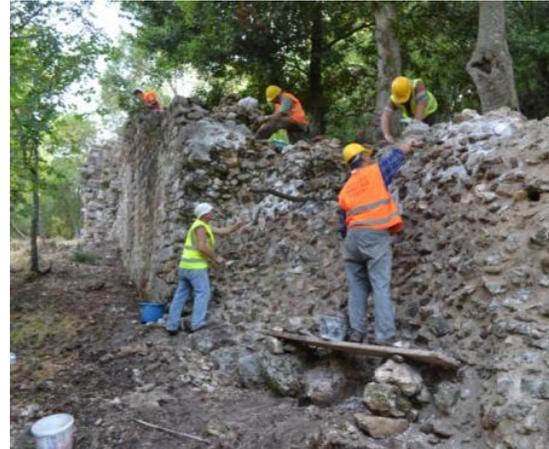
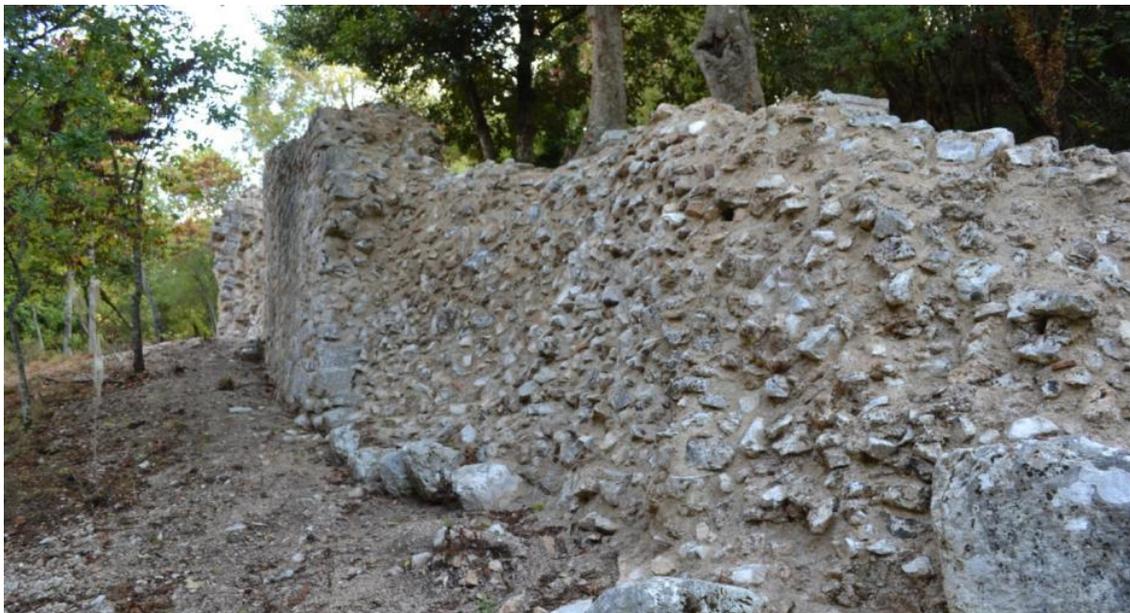
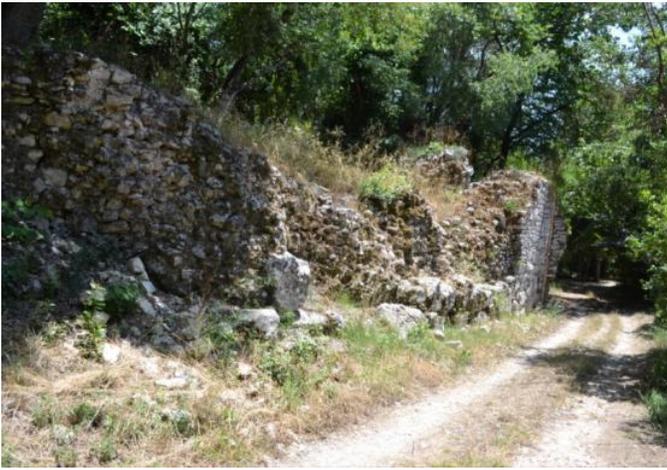
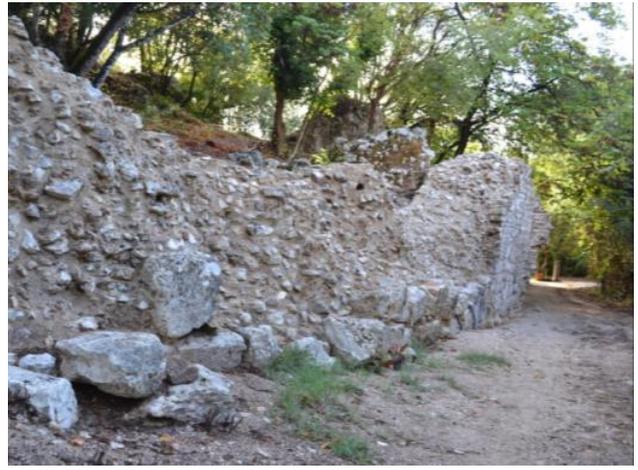
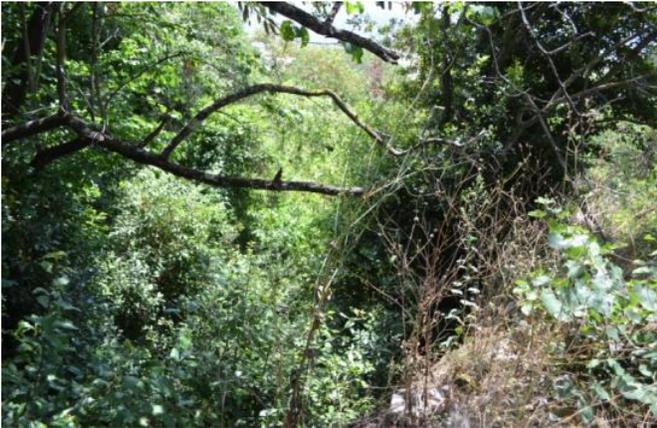
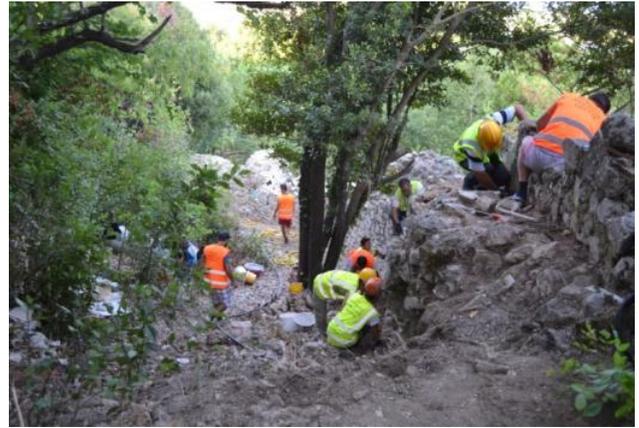
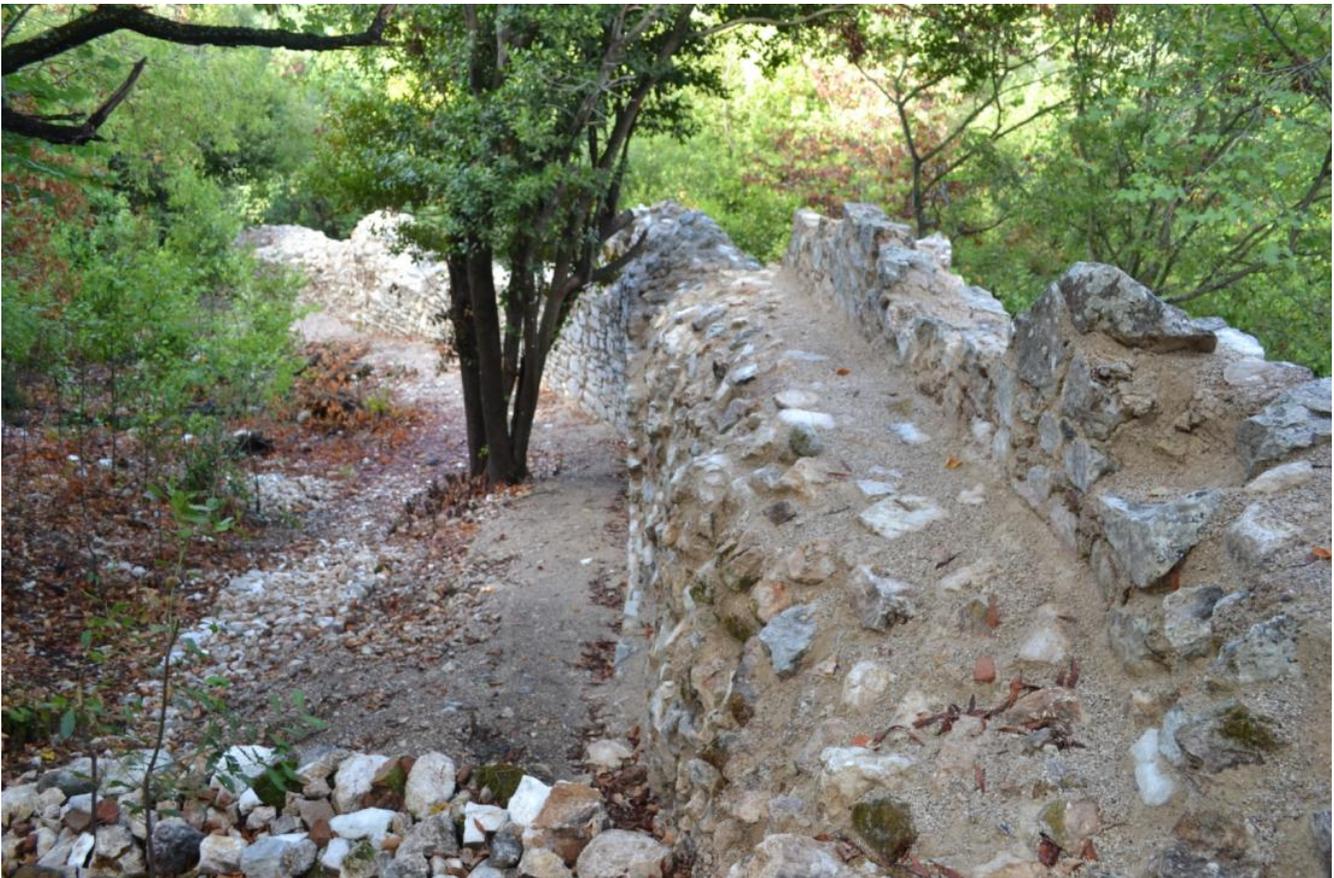
This wall represented considerable difficulties and required increased volumes of work for the conservations as in several sections had lost the face work and the unstable inner core was exposed. In some area the wall serves also as terrace wall withstanding pressure and tensions from the hillside, therefore penetration and consolidation in the depth of the wall was considered crucial and so a lot of injections of lime mortar was made. Also due to the several phases of construction special attention has been given to preserve the lines and joints of different phases.

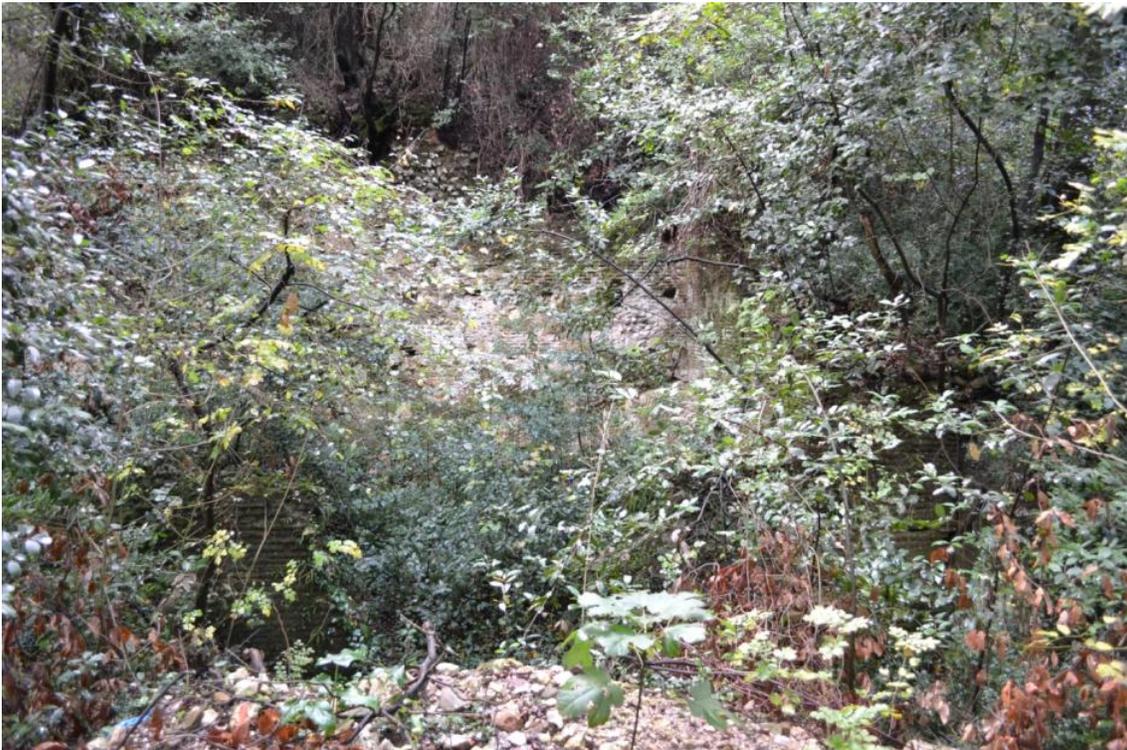
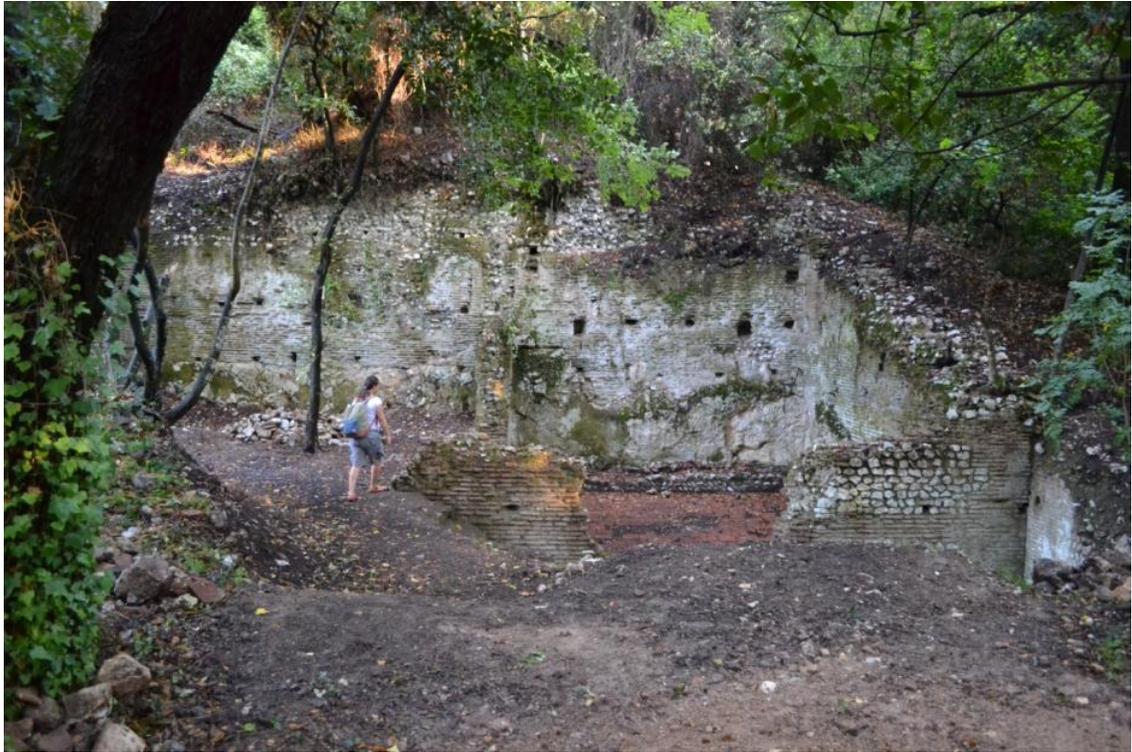
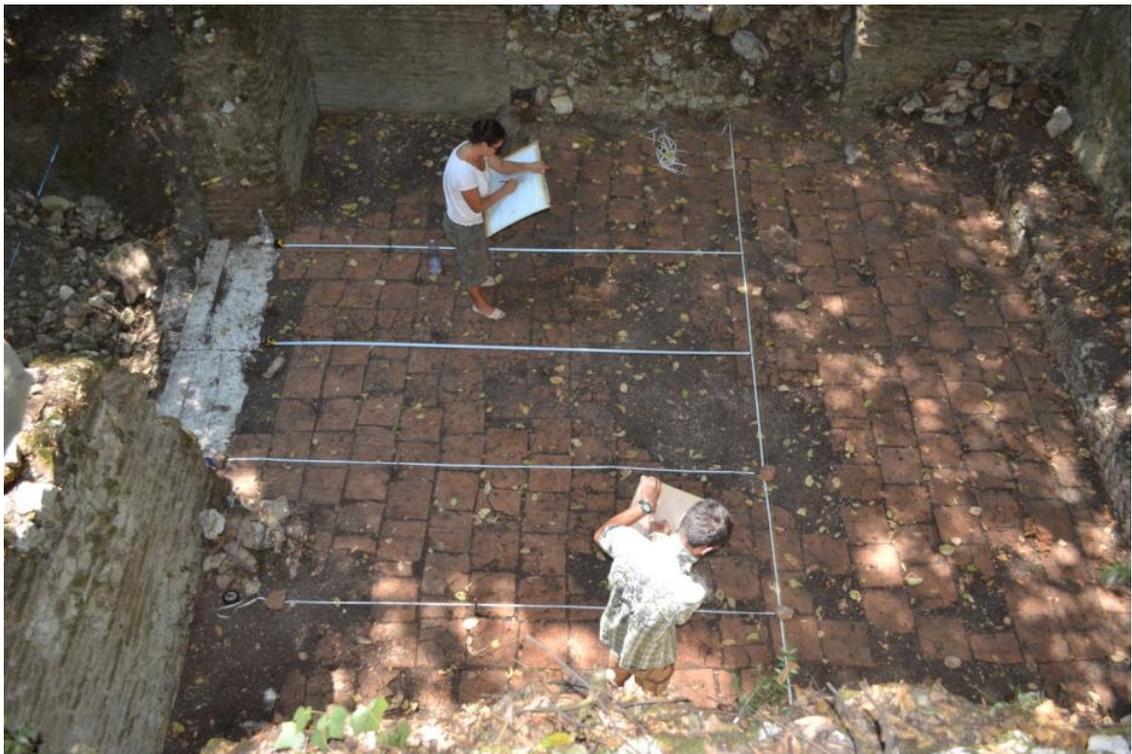
This monument located in the adjacent east of the Forum was totally isolated in the forest of Butrint. An extensive vegetation clearance was undertaken in and around the monument. After that the structure was exposed a detailed cleaning of the topsoil and material was done inside the building in order to expose elements that were already excavated in the past and impressive tiled floors were found in two of the rooms. More difficulties were faced for cleaning the sections of the trenches, which were discovered to be remains of material thrown there from other digs and presented no stratigraphy, also showing that the size of excavation from Ugolini or other later researches was probably not restricted only for the interior area of the structure.

Considering the limited resources of the project for extending the survey and excavation, it was decided that the work will only be limited in documenting the existing exposed structure and a preliminary conservation of unstable structure elements.

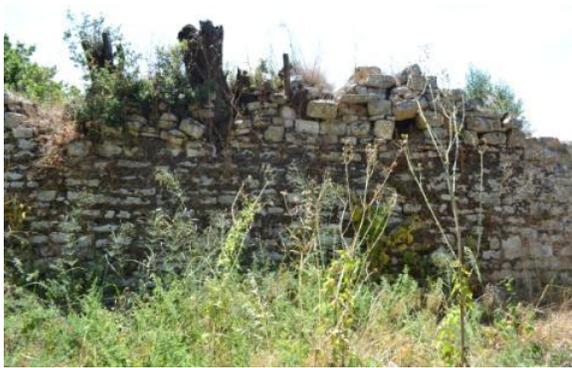
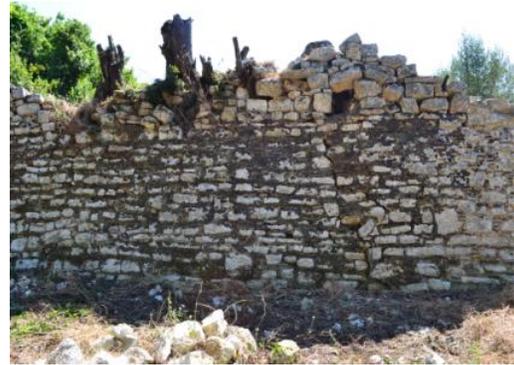
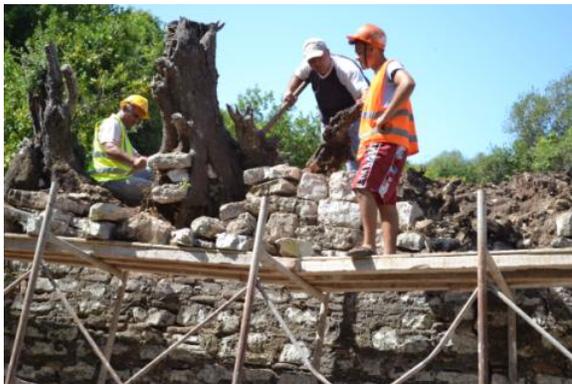
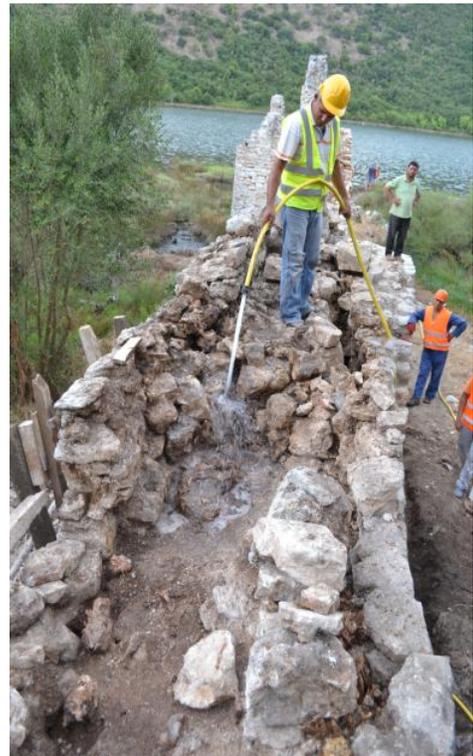
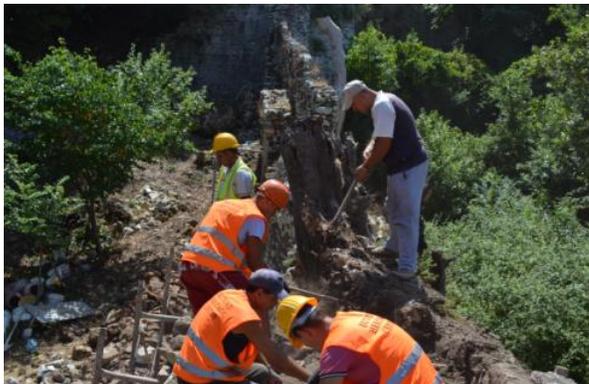
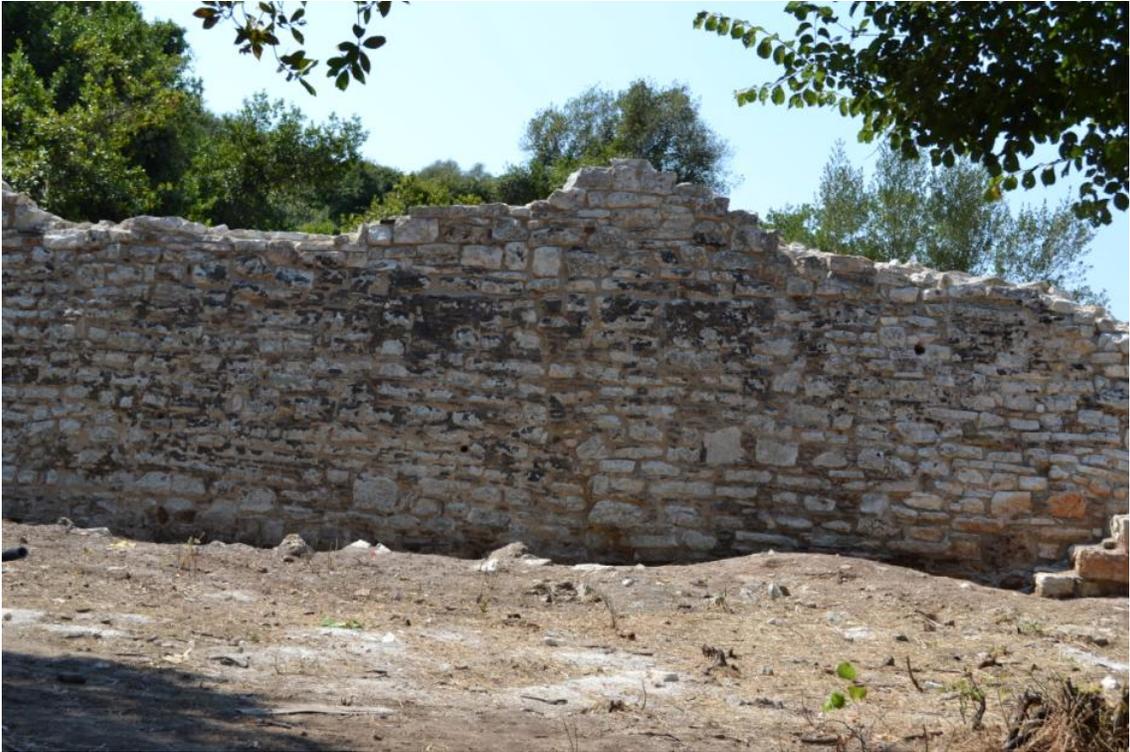
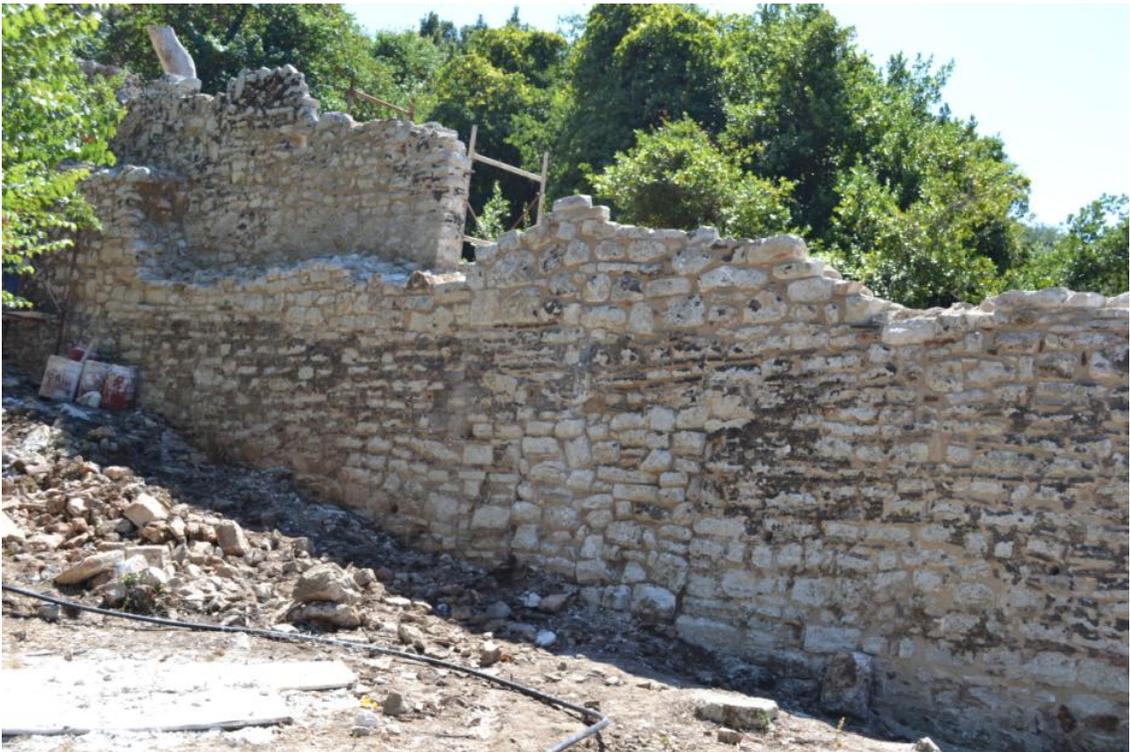
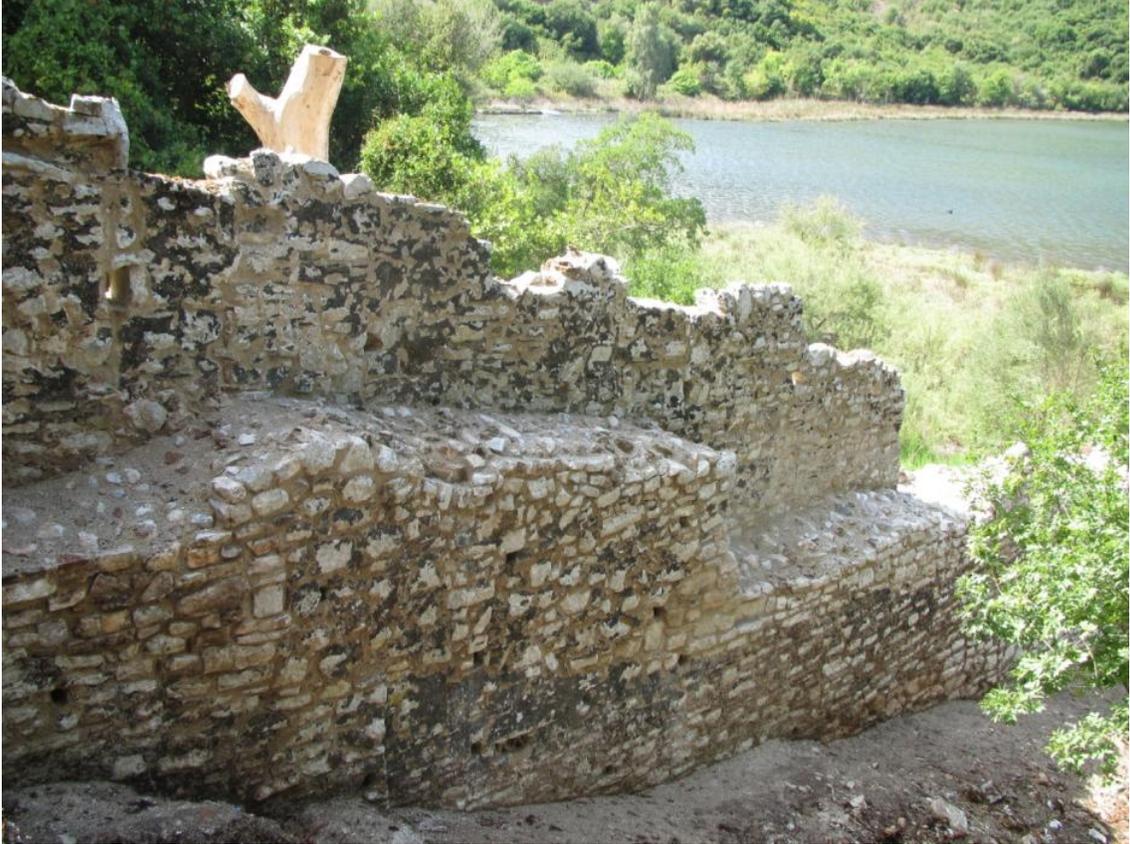
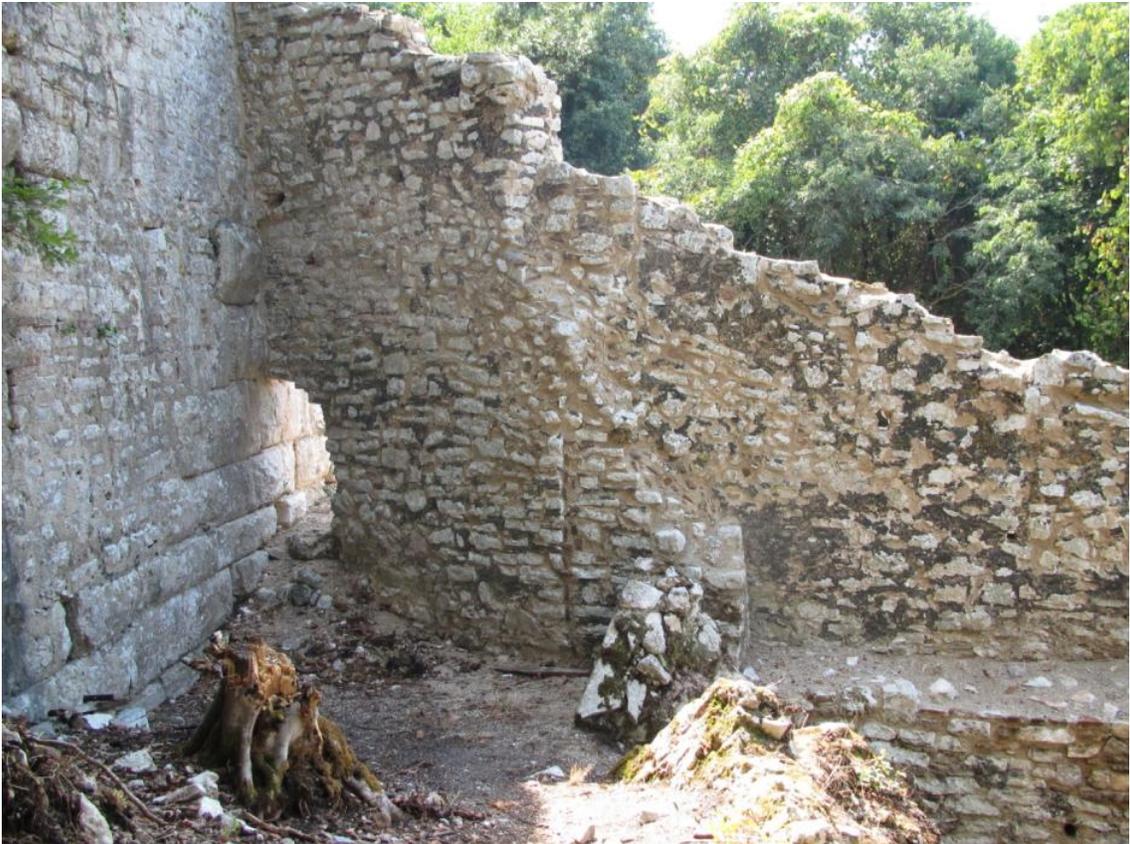
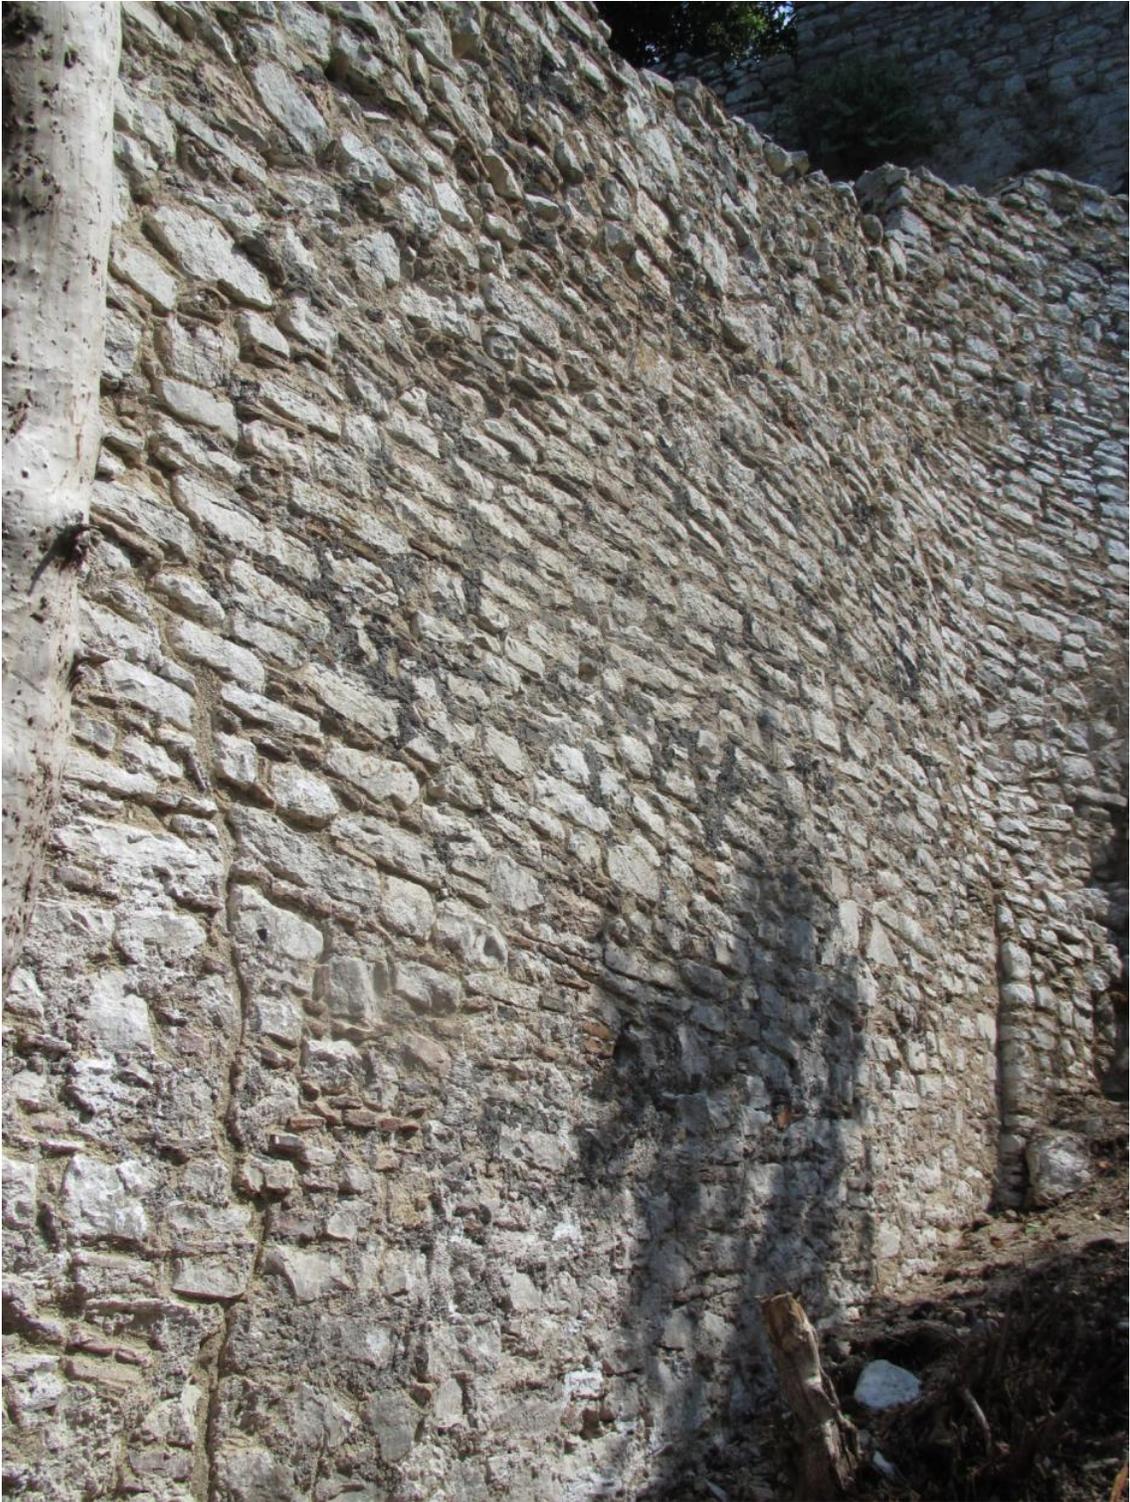
This season were successfully completed some unfinished works, which remained from last year due to the change of permits procedures, for the consolidation of the structure of the the North West Spur Wall. This section was one of the major challenges of any conservation works that have been undertaken so far at the medieval surrounding walls, due to the fact that in some sections the damage of the growing trees had undermined the wall structure and several rows of stones had to be removed and reinserted with the anastylosis technique. As well this wall has some of the highest sections reaching about 8 meters.

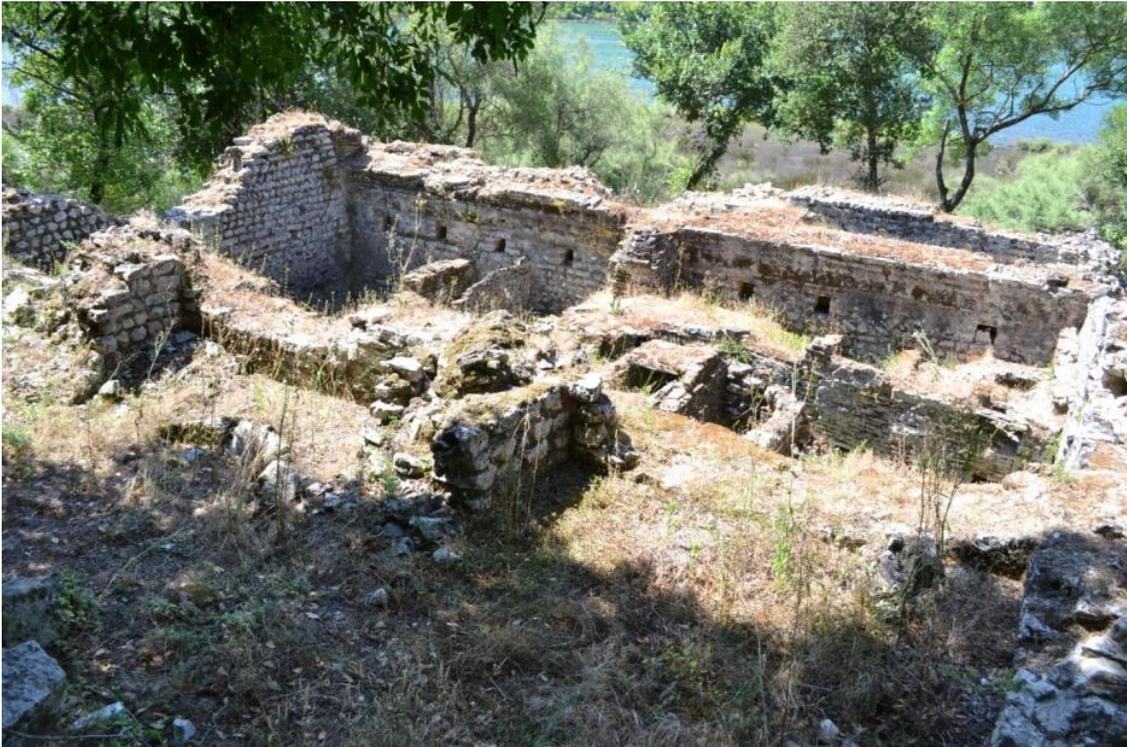
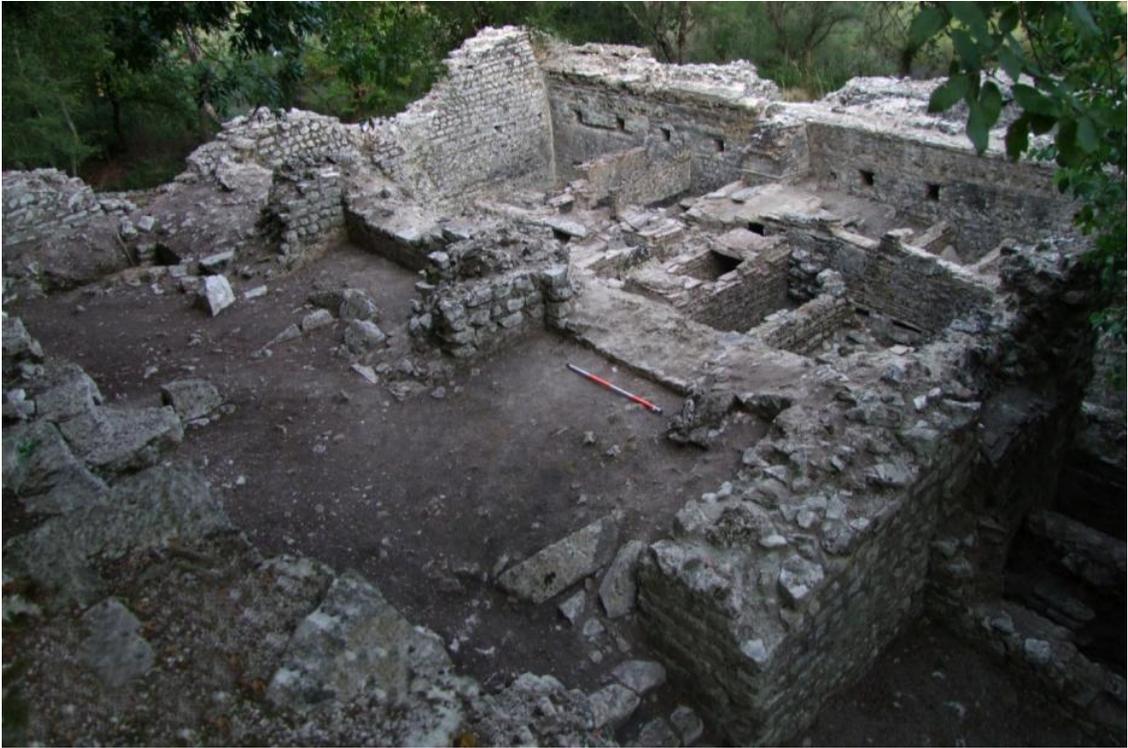
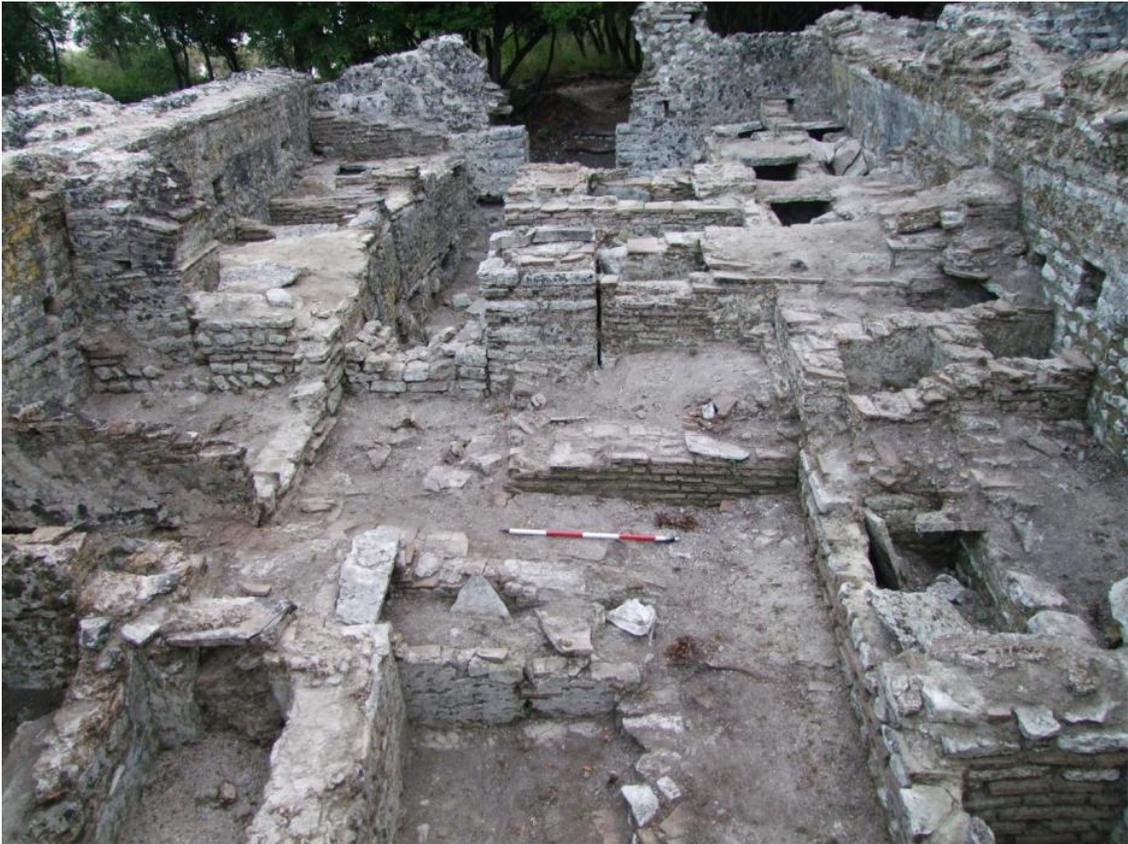
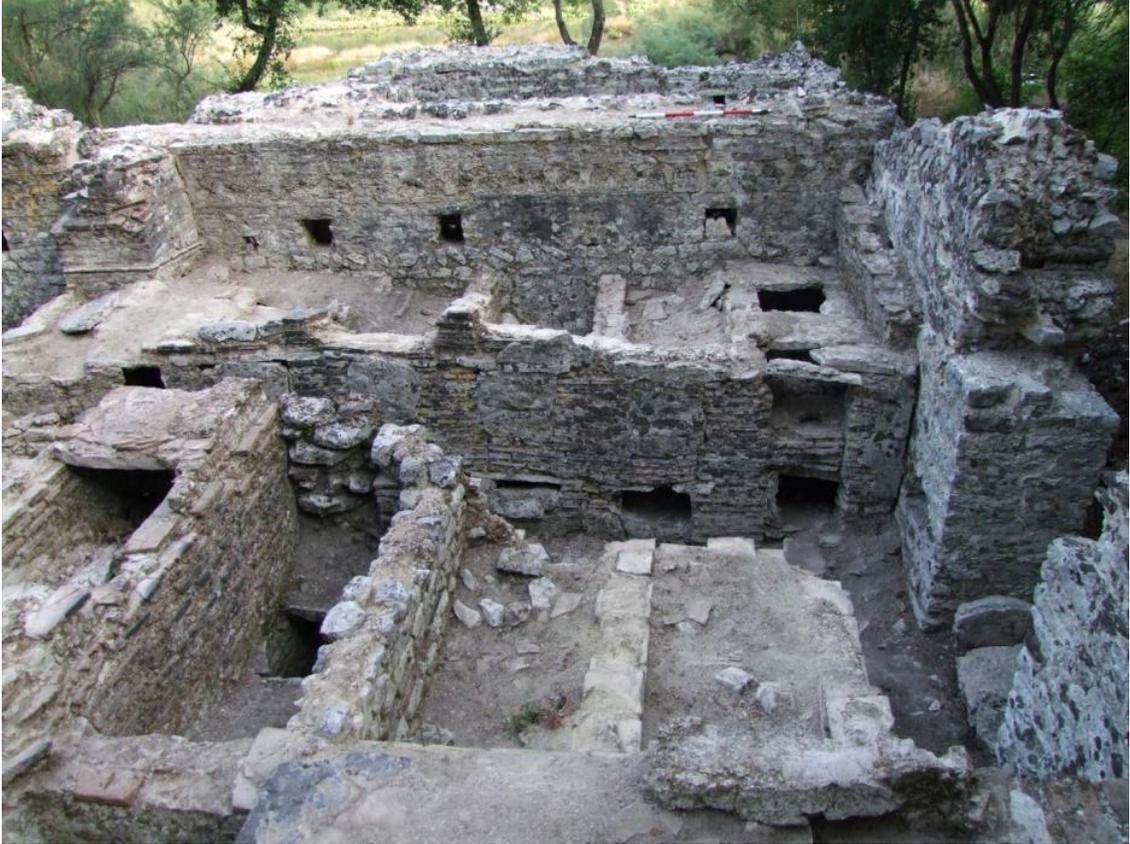
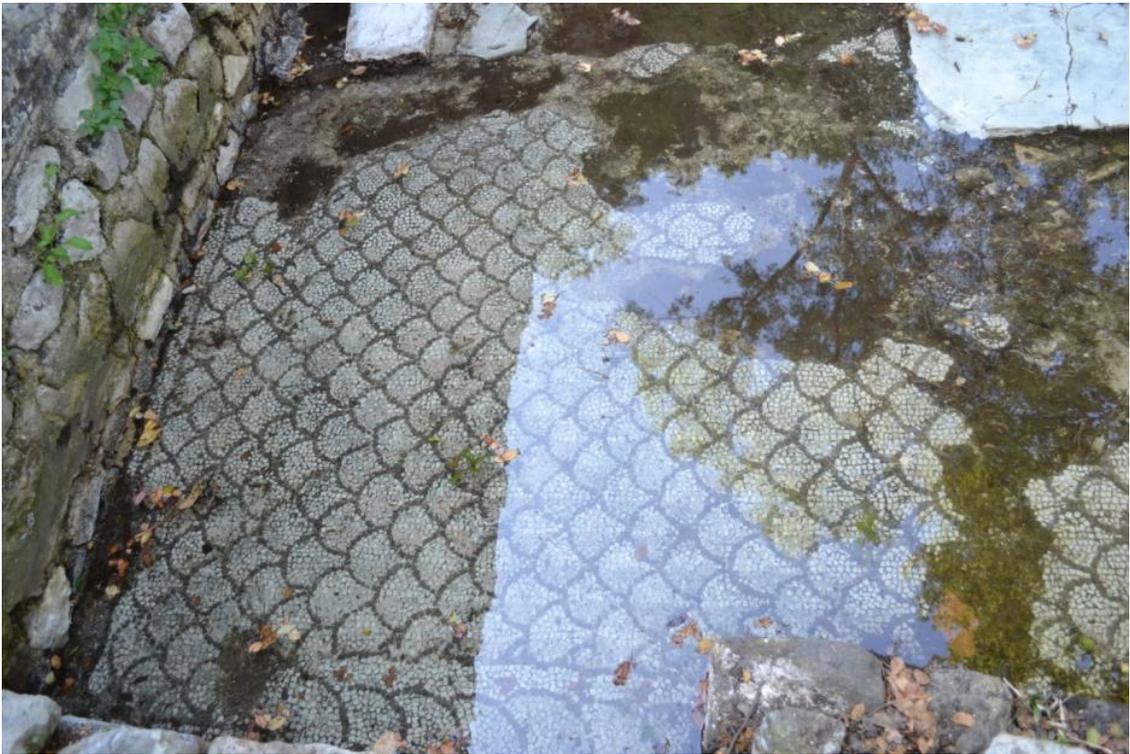
In this season, the work undertaken at this monument was focused in the consolidation of the structure in the northern side and the archaeological reassessment.

Prior to the archaeological documenting a detailed cleaning was done in the monument so that all lines of phases, wall joining, and other elements that bear interpreting clues were exposed. This was done in such a way not to disturb the stability of the structure. Following the photographs from Ugolini's excavations, the mosaic pavement was also cleaned and documented and properly backfilled with sand.

As part of the archaeological reassessment the monument was documented including structure plans, phasing and detailed drawings of the wall sections and context sheets were filed for the masonry elements. Also a general plan of the monument was produced using TST and GPS for coordinates.
